Case Study

TARARUA DISTRICT COUNCIL SADDLE RD

Client & Consultant: Tararua District Council

Contractor: Infracon Ltd

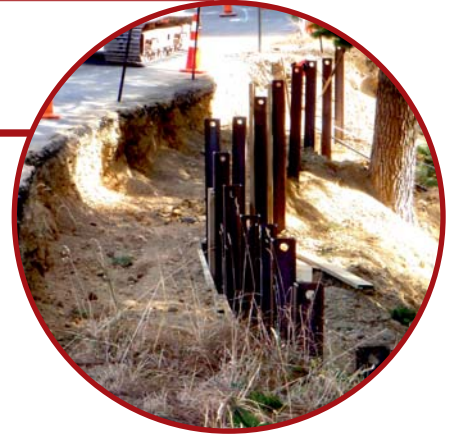
The client designed their own repair for these corner dropout sites which comprised a steel beam and timber wall with Platipus Anchors. B06 Anchors were driven to 5m at 1.5m centres and proof tested to 100 kN resulting in a rapid repair and a structurally sound solution.

Anchor System: B06 galvanised spheroidal graphite iron anchor c/w with 5.8m x 16mm Ø stainless steel wire tendon.

Quantity: 52

Anchor Design Life: 50 yrs

Soil Type: Very Firm Dry Silts
